June 21, 2011

Re: Old City Hall Building Assessment

Foss Architecture & Interiors

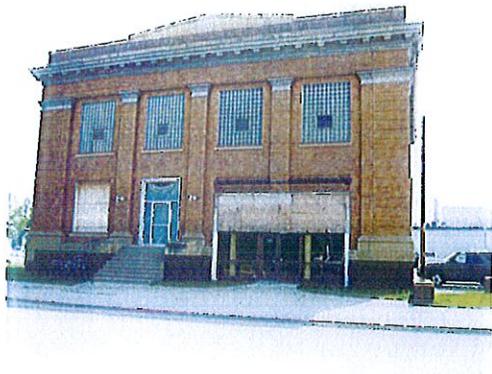
1. West Elevation. Canopy structure over ground level entry has been remove. Lower left window is boarded up.

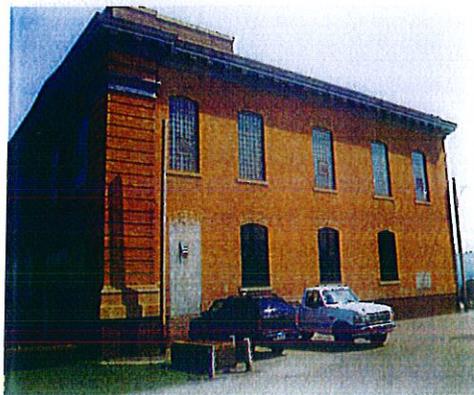
2. South Elevation. New aluminum windows have been installed in three lower windows.

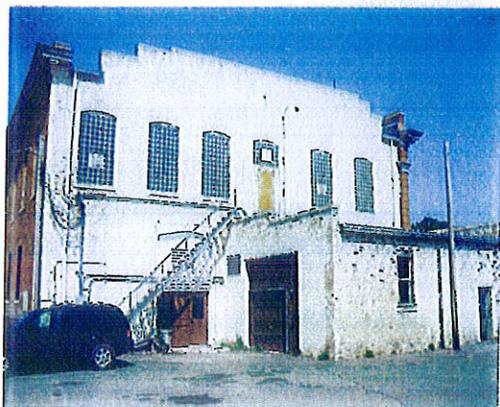
3. East Elevation. Roof drains via downspouts on either side of this elevation. Garage structure is an addition.

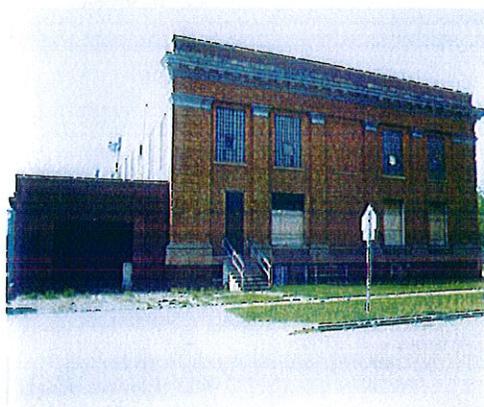
4. North Elevation. Lower windows have been removed and openings boarded up. Garage door has been removed and structure is open to the elements.

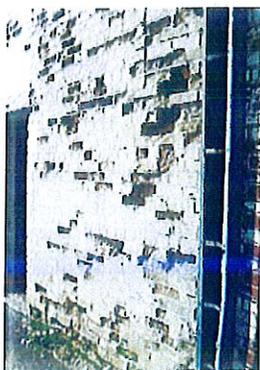
The exterior of the garage addition exhibits severe brick deterioration that warrants demolition.

5. East wall of garage addition exhibits severely spalled brick.

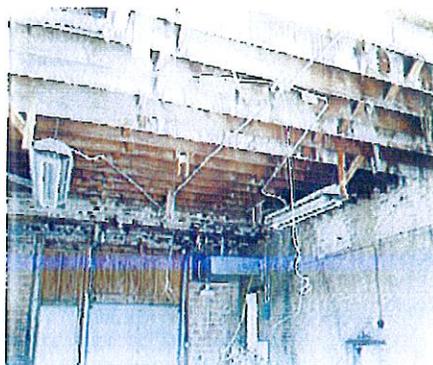
The garage addition on the east side of the building has remained opened to the elements for some time and is home to many pigeons.

6. Interior of garage is exposed to the elements and is deteriorating. Heavily invested by pigeons.

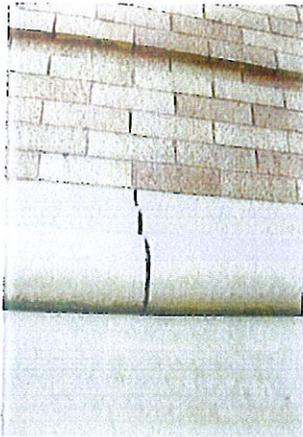
7. Joint in stone banding requiring tuckpointing.

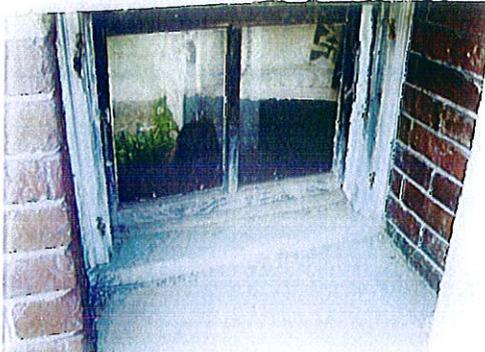
8. Basement wood window.

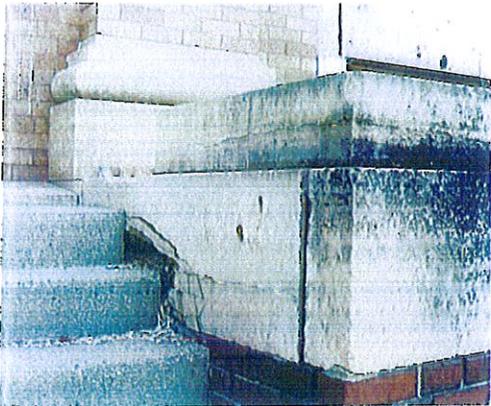
9. Deteriorating stone condition at front steps.

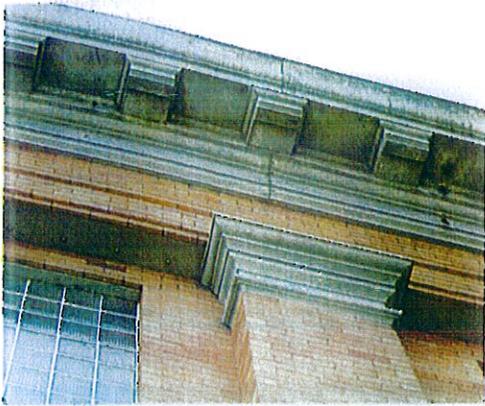
10. View from below of metal cornice and column capital.

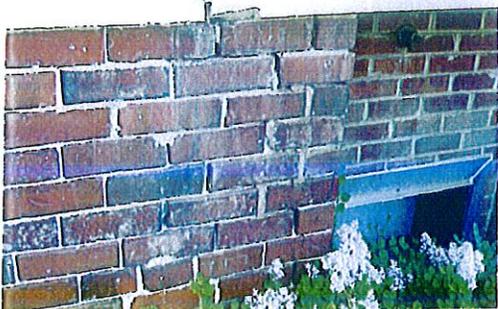
11. Typical condition at foundation showing settlement and deterioration of masonry joints

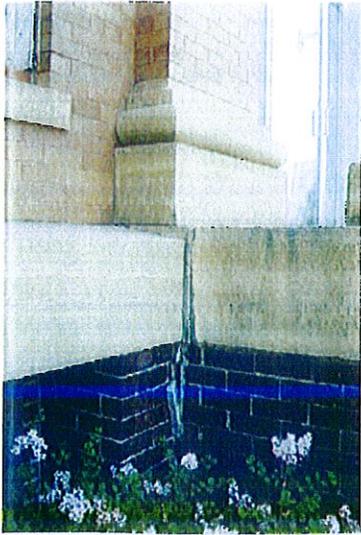
12. Deterioration of masonry joints at front steps.

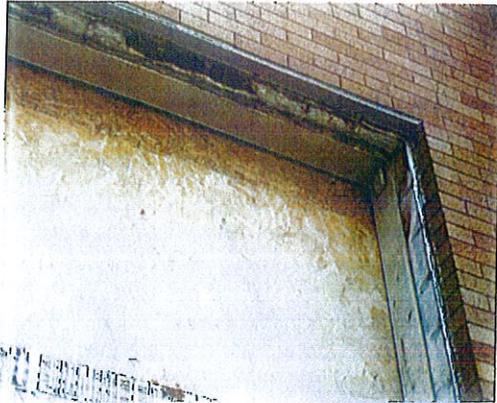
13. Existing window opening where window has been removed.

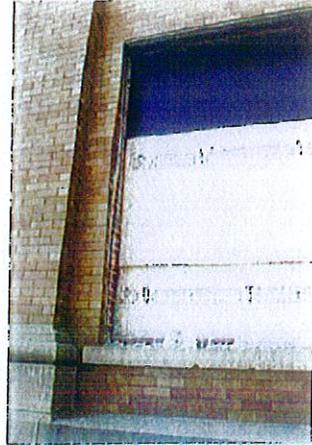
14. Existing window opening where window has been removed.

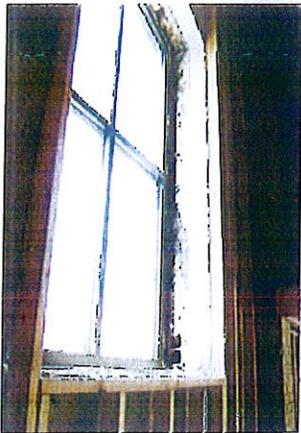
15. View from inside of existing window opening with new aluminum window. Wood framing is new from abandoned remodeling project.

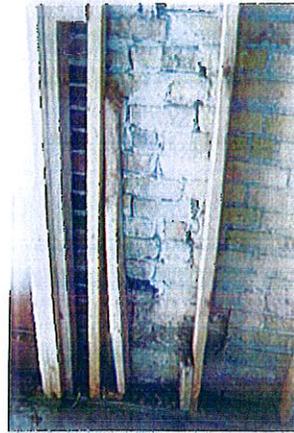
16. Inside view of back-up masonry near opening showing deterioration of masonry.

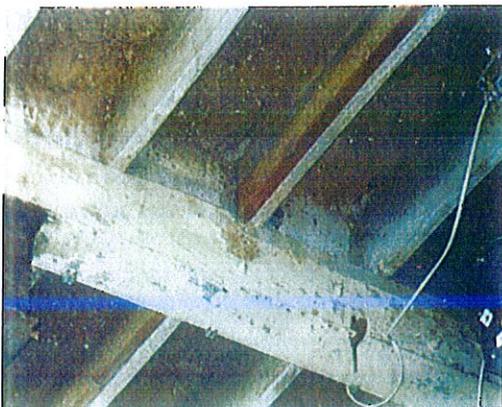
17. Steel beam supporting wood joists. Joists rest on wood ledger bolted to each side of beam web. Only bottom flange of beam is visible.

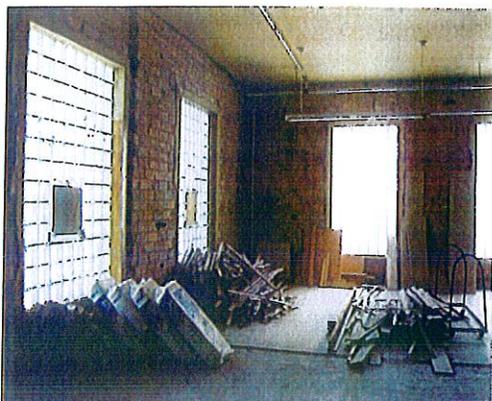
19. Interior view of second floor showing glass block windows.

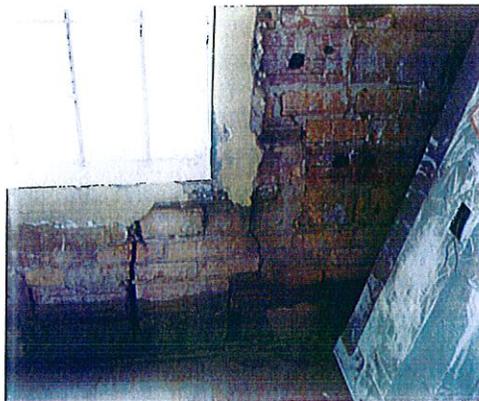
20. Clay tile back up of exterior wall at second floor.

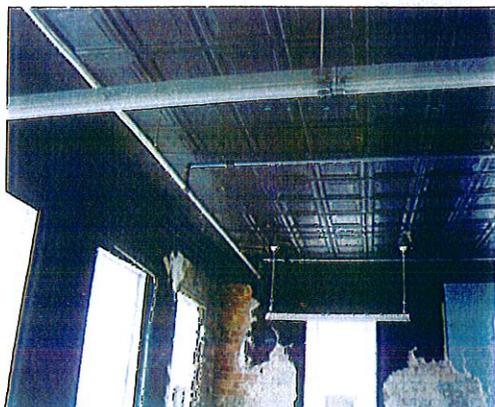
21. Tin ceiling and deteriorating plaster at second floor.

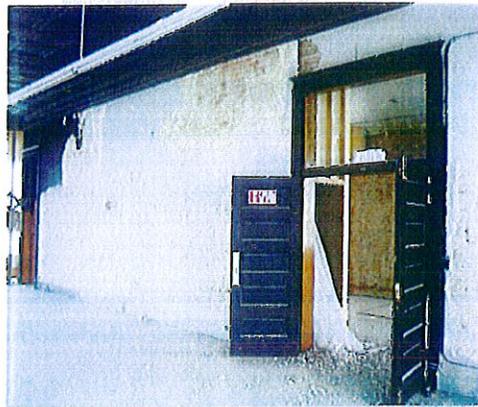
22. Interior wall at second floor showing condition of plaster

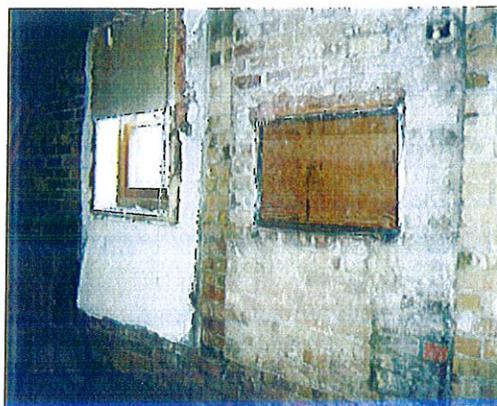
23. Interior of walls at basement showing masonry and blocked window openings.

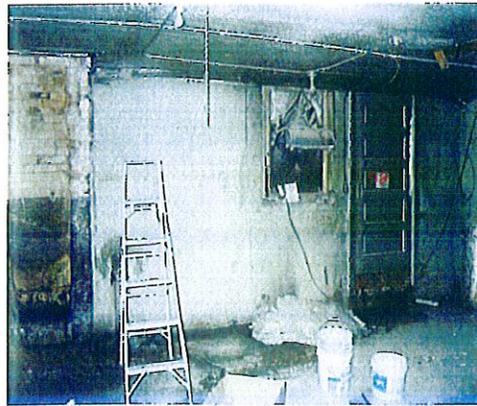
24. Basement wall at north elevation with exit door (on right).

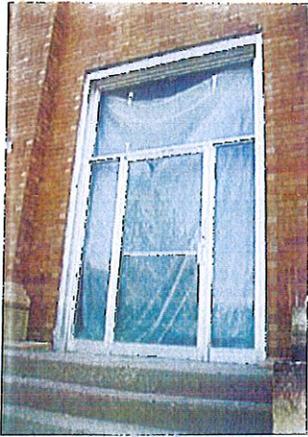
25. Aluminum entry on west elevation.

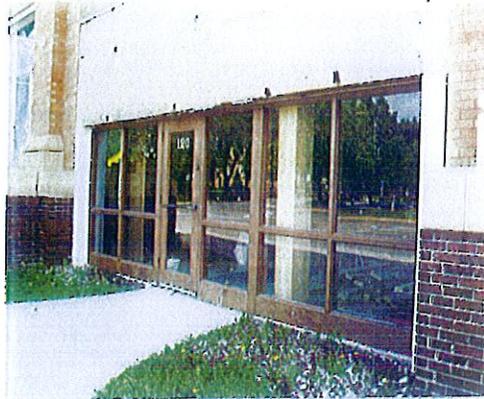
26. Hollow metal entry framing on west elevation.

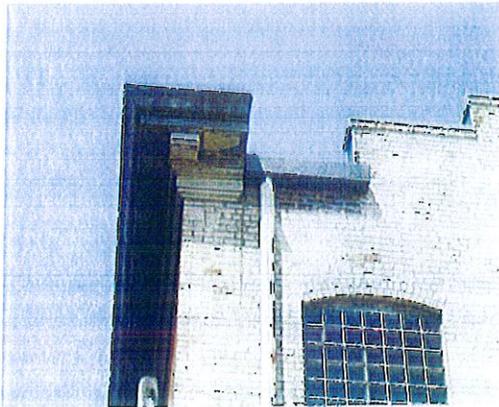
27. Cornice, gutter and downspout on southeast elevation.

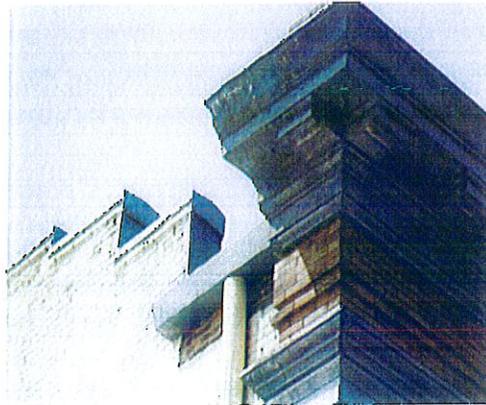
28. Cornice, gutter and downspout on northeast elevation.

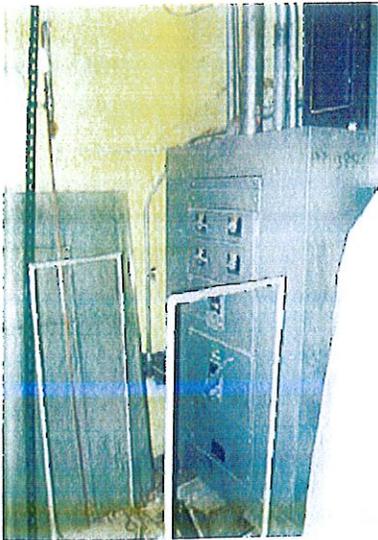
29. Electric service panel disconnected from power.

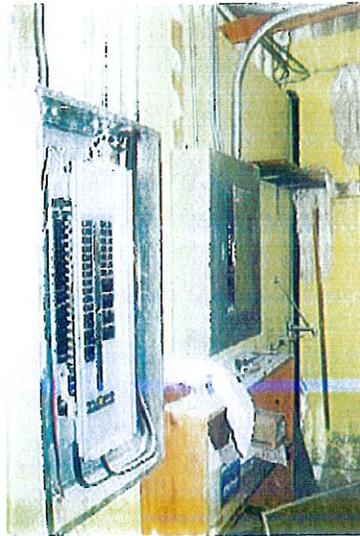
30. Existing electrical distribution panels.

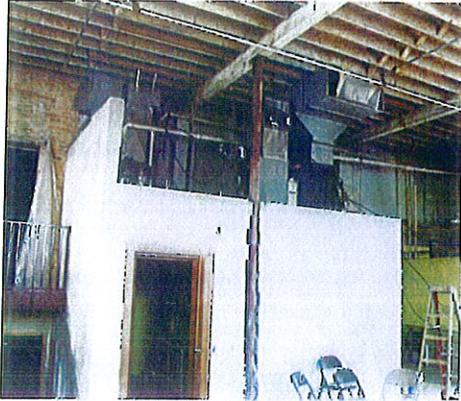
31. Mechanical furnace and equipment remaining on top of vault structure.
