Asbestos and Hazardous Materials Assessment

Wahpeton Public Schools
Central Elementary School
212 3rd Avenue North
Wahpeton, ND 58075-3927

September 16, 2015

Trio Project #T15-213

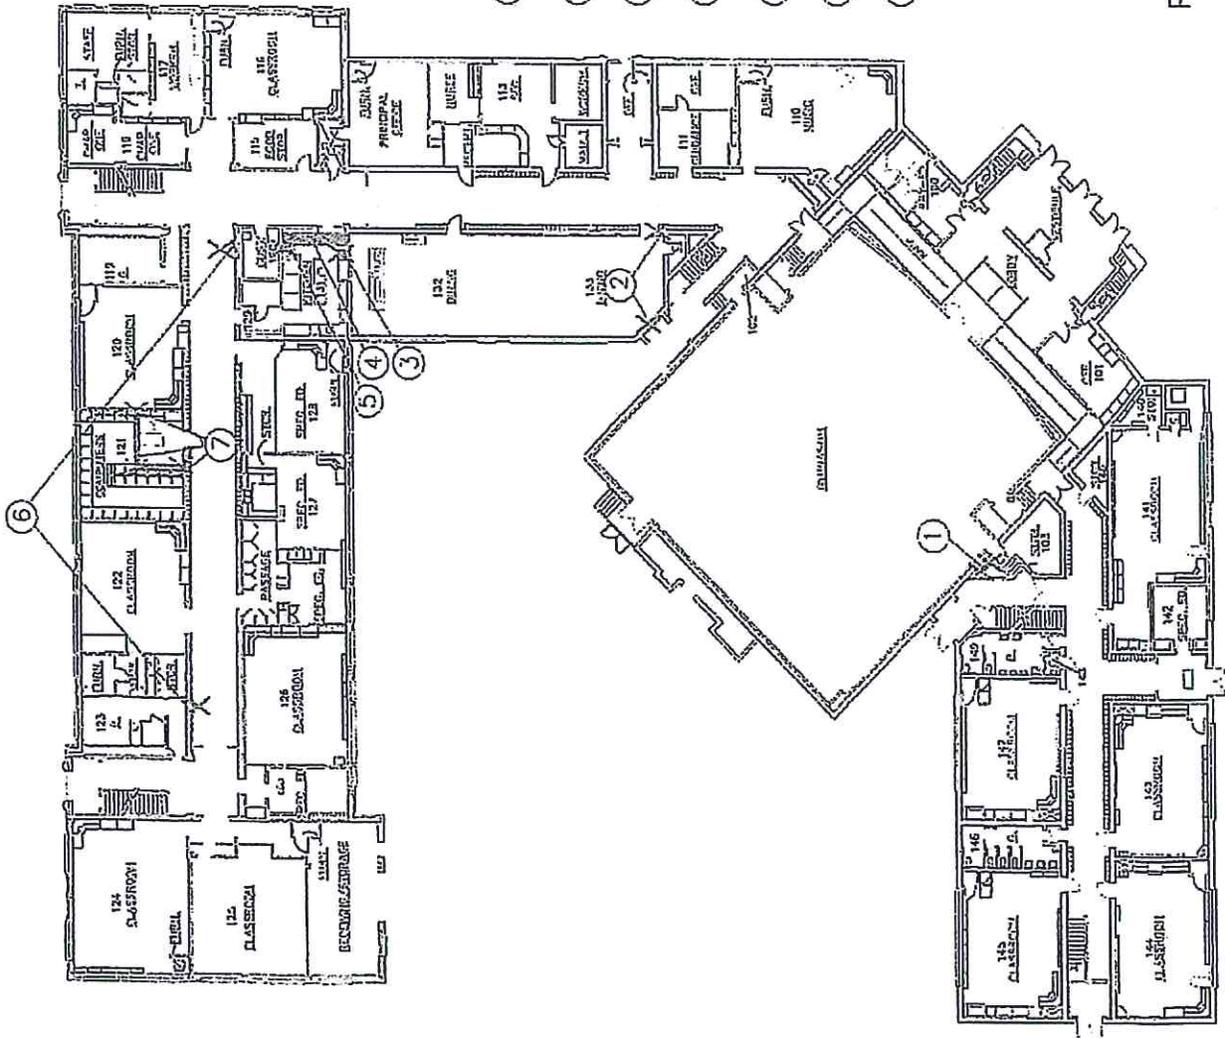
WAHPETON CENTRAL
ELEMENTARY SCHOOL
1929/1949 BUILDINGS
FIRST FLOOR
ACM LOCATIONS

- ① -2 VERTICAL STEAM SUPPLY LINE FROM BASEMENT TO ATTIC
- ② -2 VERTICAL DOMESTIC WATER LINES IN WALL AND CHASE
- ③ -3 DOMESTIC WATER LINES IN VERTICAL CHASE IN KITCHEN
- ④ -3 DOMESTIC WATER LINES ABOVE SUSPENDED CEILING TILE IN KITCHEN
- ⑤ -3 DOMESTIC WATER LINES IN VERTICAL WALL IN EAST WALL OF KITCHEN
- ⑥ -DOMESTIC WATER SUPPLY LINE IN WALL SERVING DRINKING FOUNTAIN
- ⑦ -VERTICAL STEAM IN WEST WALL & ABOVE SUSPENDED CEILING TILE, VERTICAL DOMESTIC IN SOUTH WALL & ABOVE SUSPENDED CEILING TILE

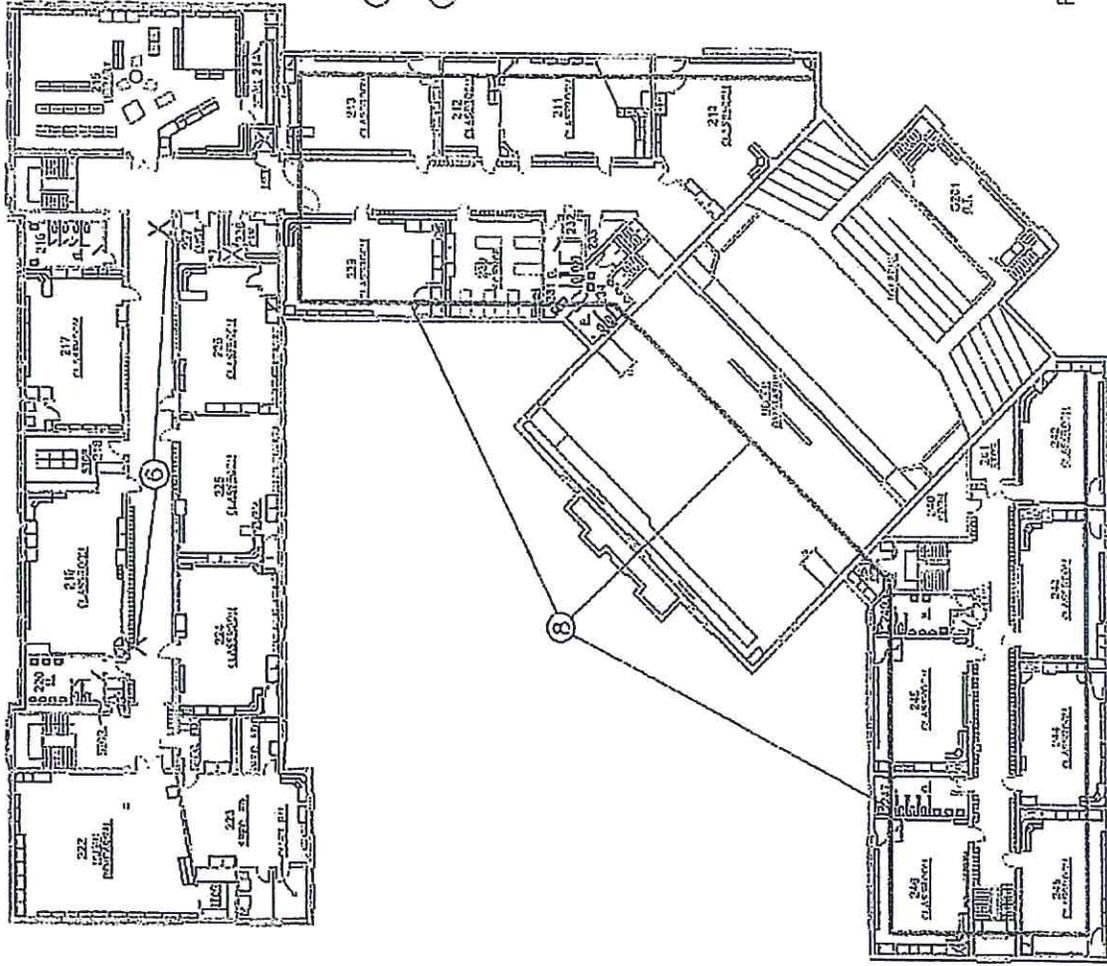
WAHPETON CENTRAL
 ELEMENTARY SCHOOL
 1929/1949 BUILDINGS
 SECOND FLOOR
 ACM LOCATIONS

- ⑥ -DOMESTIC WATER SUPPLY LINE IN WALL SERVING DRINKING FOUNTAIN
- ⑧ STEAM LINE IN ATTIC; MAG BLOCK (6") AND AIR CELL (4")

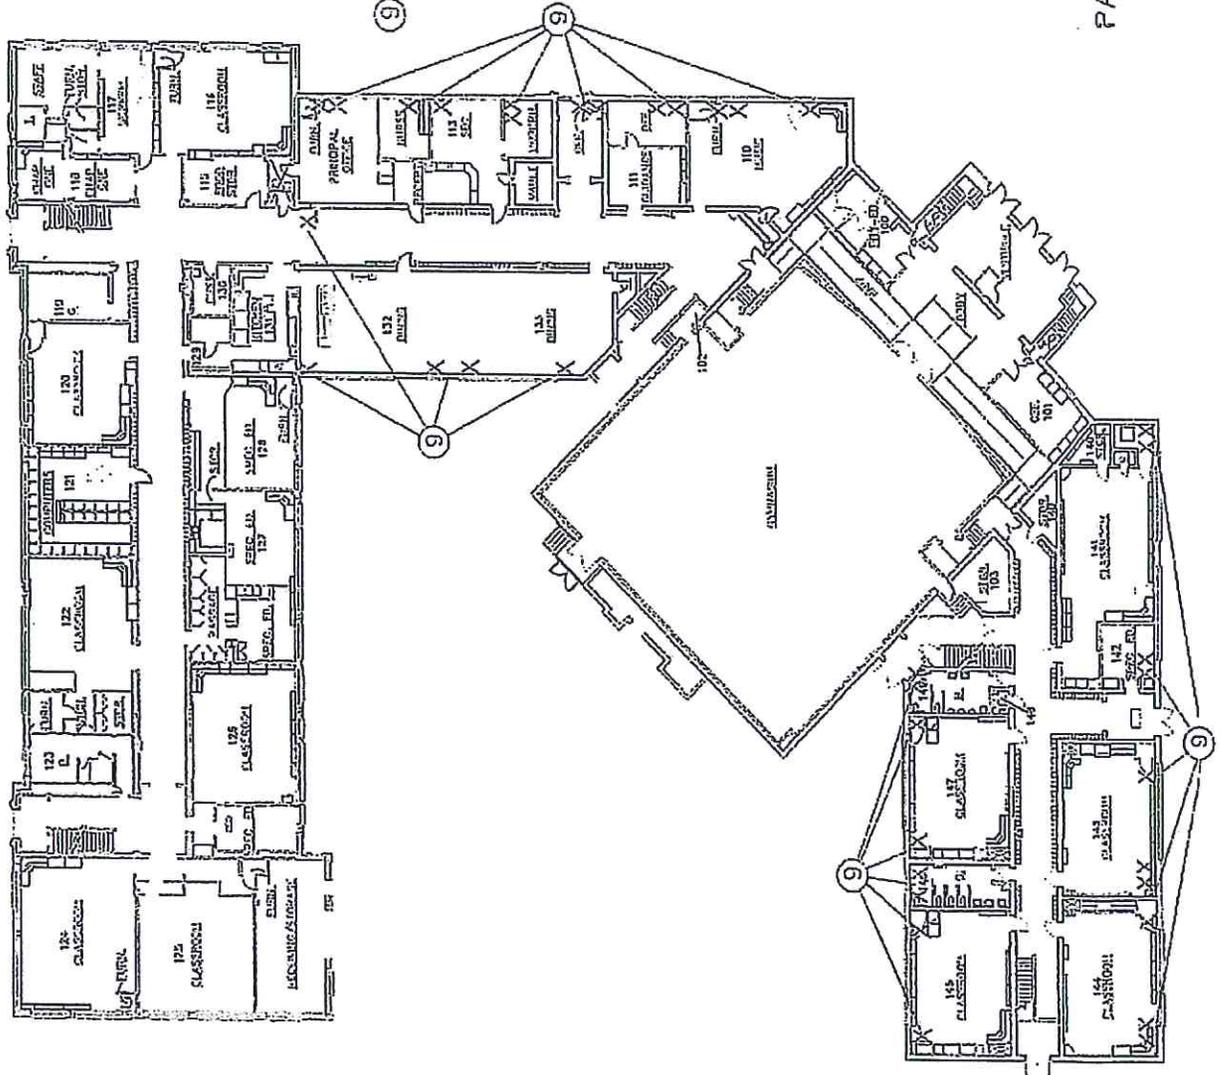
WAHPETON CENTRAL
ELEMENTARY SCHOOL
1929/1949 BUILDINGS
FIRST FLOOR
ACM LOCATIONS

⑨ - REMNANT STEAM LINE RISERS IN PLASTER
CEILING; AIR CELL APPROX. 12"

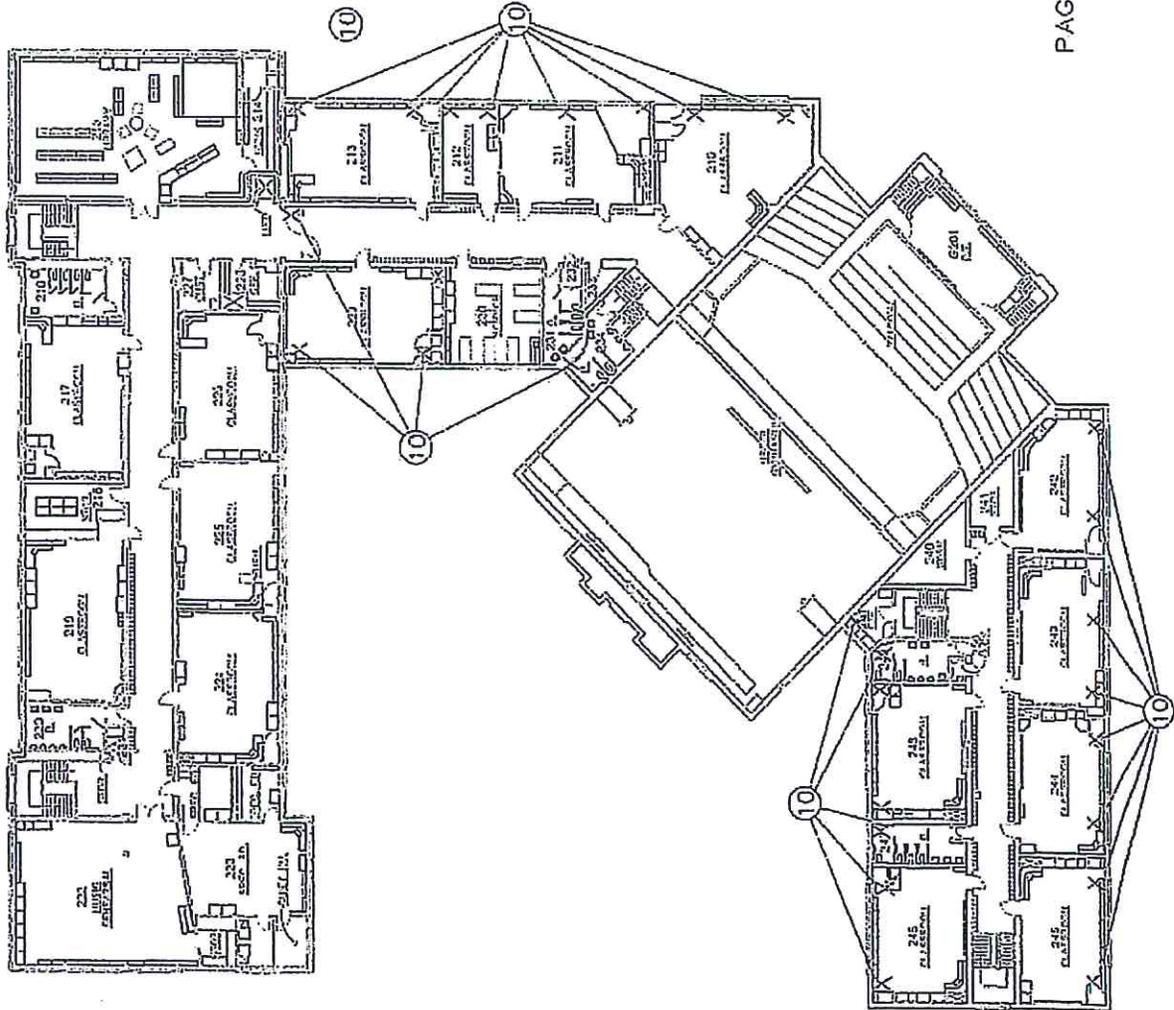
WAHPETON CENTRAL
ELEMENTARY SCHOOL
1929/1949 BUILDINGS
SECOND FLOOR
ACM LOCATIONS

⑩ - REMNANT STEAM LINE RISERS IN PLASTER
CEILING; AIR CELL, APPROX. 12"

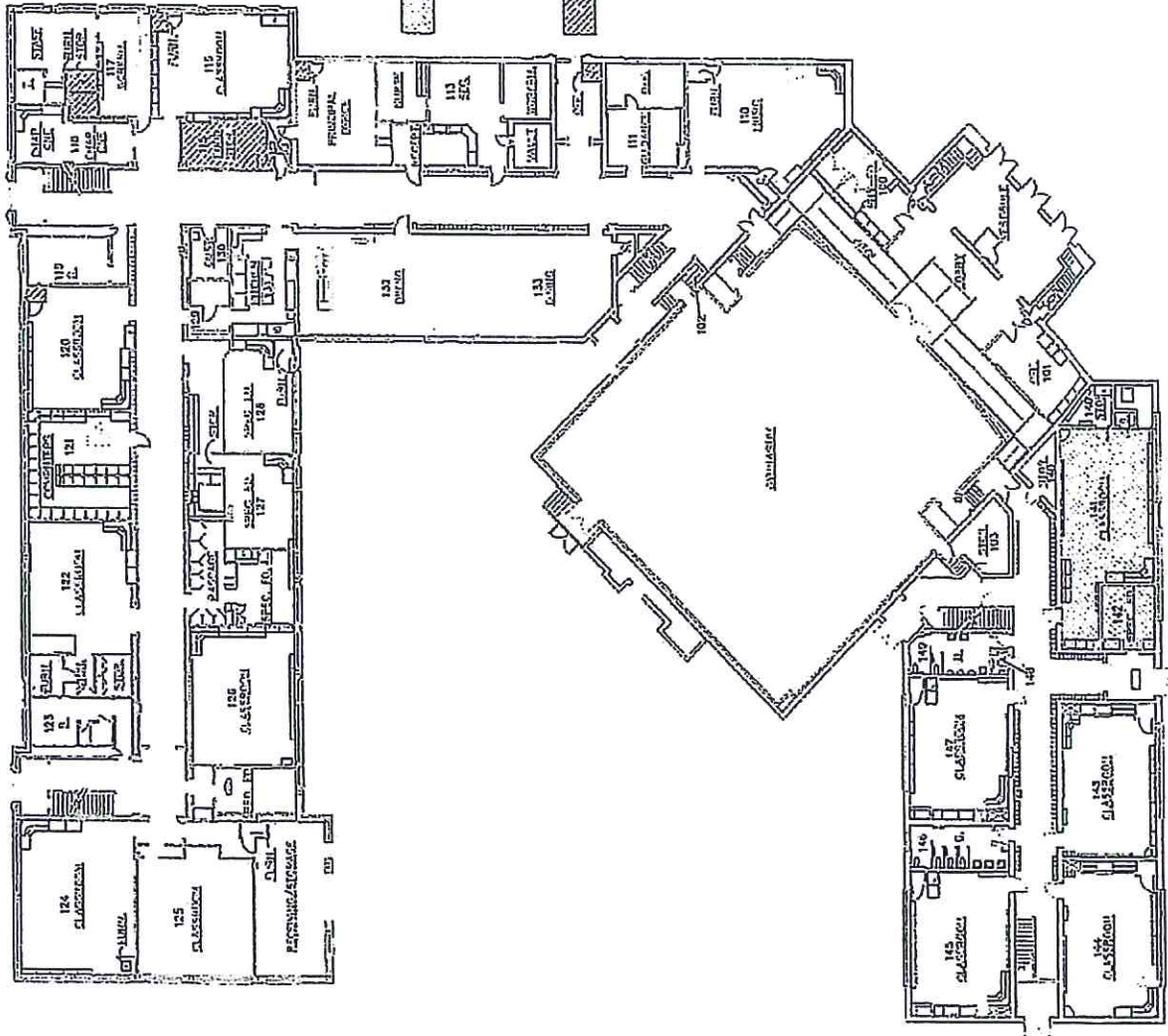
WAHPETON CENTRAL
ELEMENTARY SCHOOL
1929/1949 BUILDINGS
FIRST FLOOR
ACM LOCATIONS

-(DRAWING NOTE 1) ACOUSTICAL PLASTER ON
CEILING AND EXTENDS DOWN NORTH, EAST AND
SOUTH WALLS APPROXIMATELY 24"
(MAY EXTEND DOWN FURTHER BEHIND DRYWALL).

-(DRAWING NOTE 12) FLOOR TILE AND MASTIC
WHICH IS VISIBLE

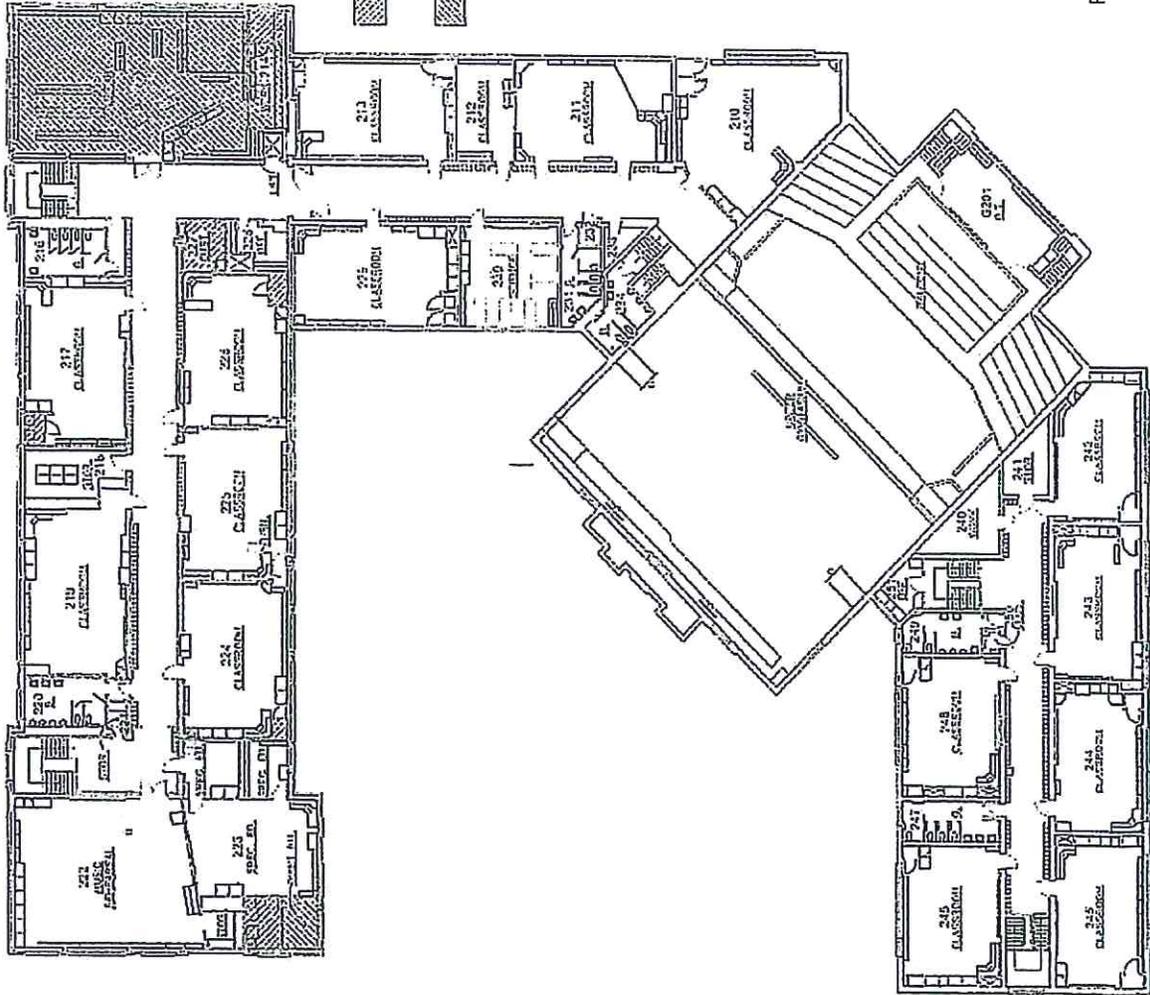
WAHPETON CENTRAL
 ELEMENTARY SCHOOL
 1929/1949 BUILDINGS
 SECOND FLOOR
 ACM LOCATIONS

(DRAWING NOTE 12) FLOOR TILE AND MASTIC WHICH IS VISIBLE

(DRAWING NOTE 13) FLOOR TILE AND ADHESIVE VERIFIED BENEATH EXISTING CARPET

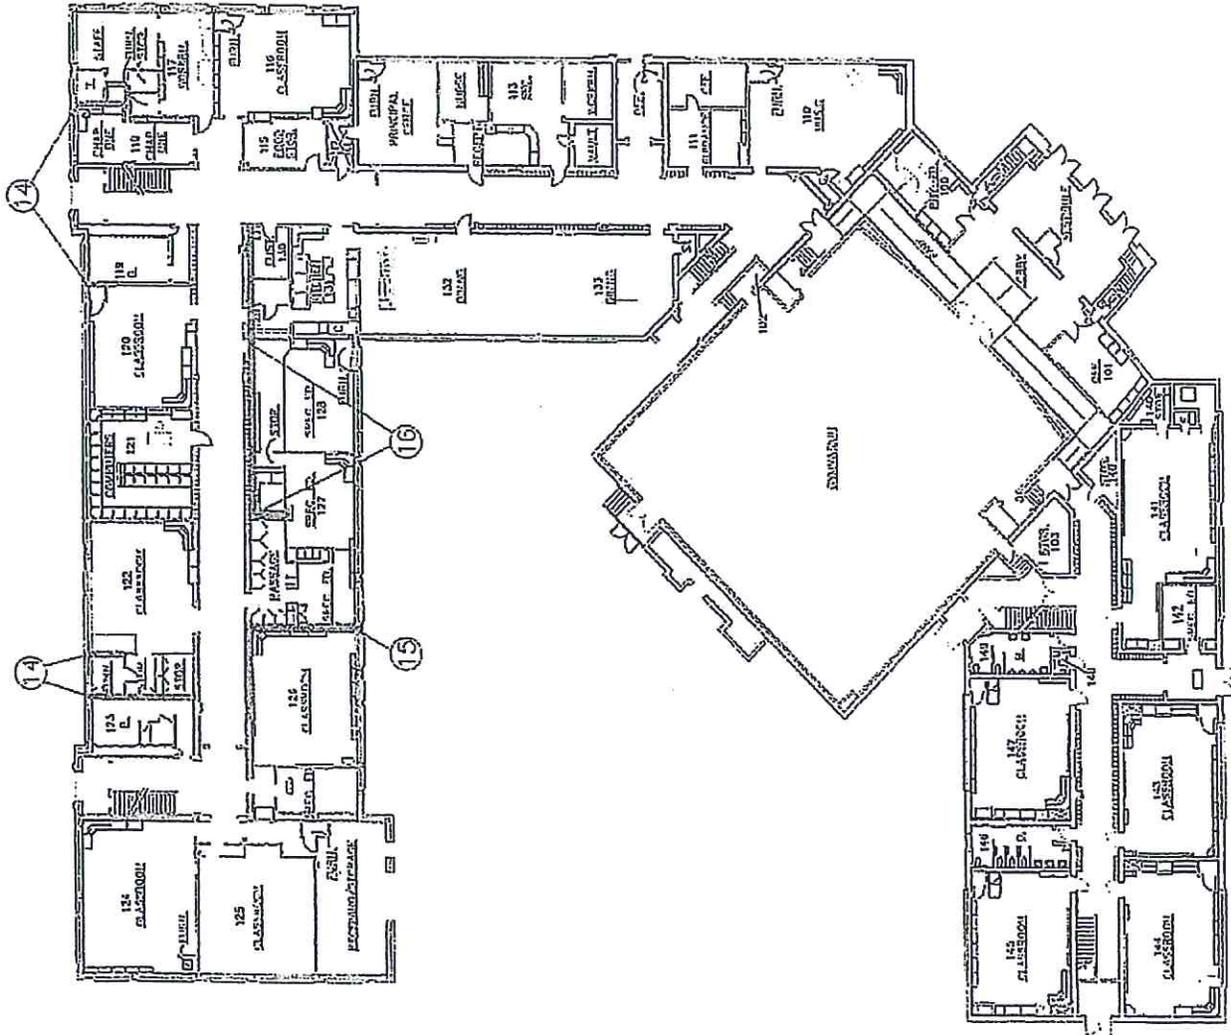
WAHPETON CENTRAL
ELEMENTARY SCHOOL
1929/1949 BUILDINGS
FIRST FLOOR
ACM LOCATIONS

- ⑭ — ASSUMED DOMESTIC WATER LINES IN WALLS BEHIND SINK
- ⑮ — ASSUMED DOMESTIC WATER LINES IN WALLS BASED ON CONSTRUCTION DRAWINGS
- ⑯ — ASSUMED DOMESTIC WATER LINES IN FURRED SPACE BASED ON CONSTRUCTION DRAWINGS

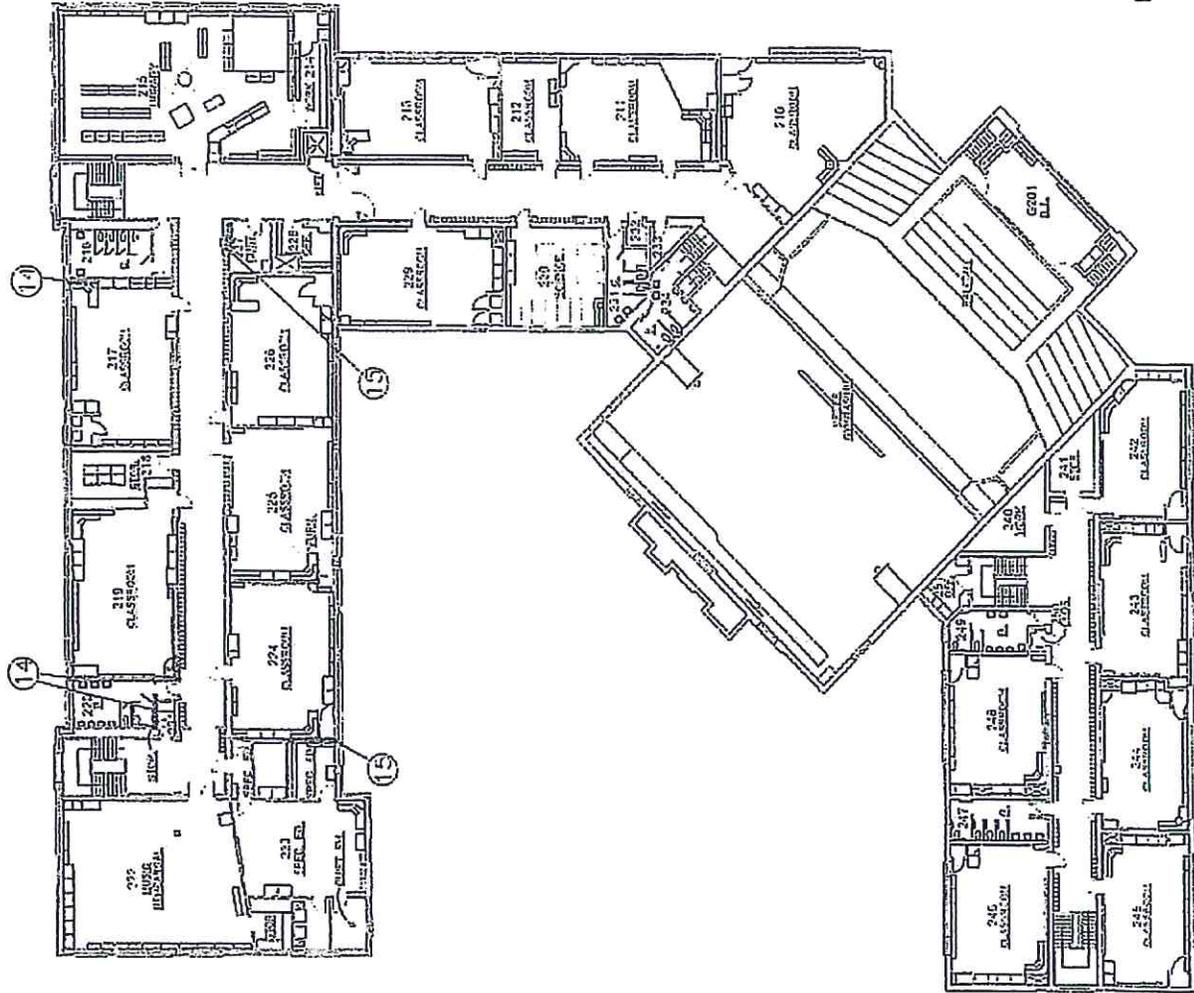
WAHPETON CENTRAL
 ELEMENTARY SCHOOL
 1929/1949 BUILDINGS
 SECOND FLOOR
 ACM LOCATIONS

- ⑭ - ASSUMED DOMESTIC WATER LINES IN WALLS BEHIND SINK
- ⑮ - ASSUMED DOMESTIC WATER LINES IN WALLS BASED ON CONSTRUCTION DRAWINGS

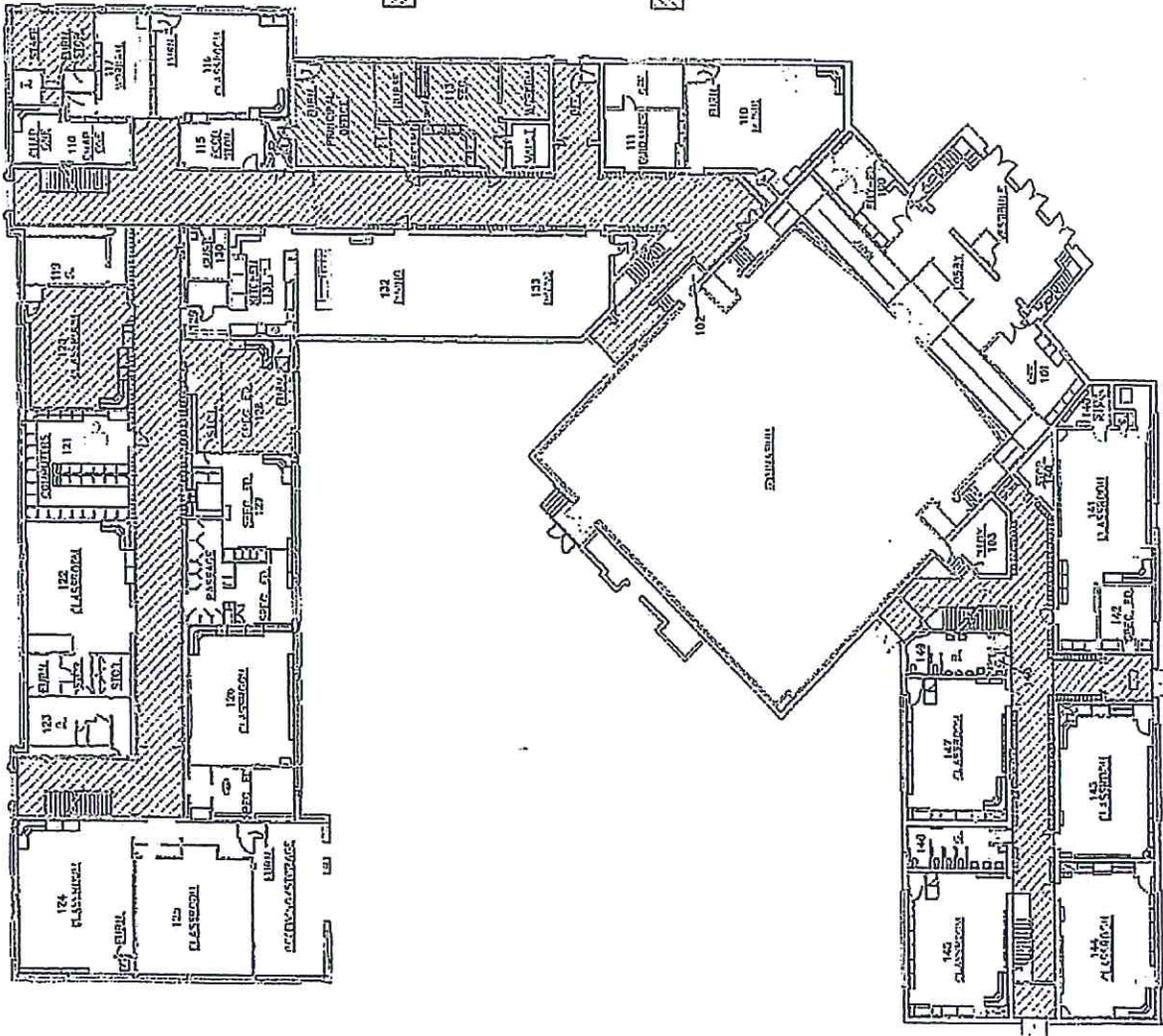
WAHPETON CENTRAL
 ELEMENTARY SCHOOL
 1929/1949 BUILDINGS
 FIRST FLOOR
 ACM LOCATIONS

—(DRAWING NOTE 17) ASSUMED FLOOR TILE AND MASTIC BENEATH NEW TARKETT FLOORING.

NO ABATEMENT RECORDS FOUND WHICH WOULD VERIFY THE MATERIAL WAS ABATED. THESE LOCATIONS WILL NEED TO BE VERIFIED, HOWEVER DAMAGE TO THE NEW FLOORING WOULD BE REQUIRED.

—(DRAWING NOTE 18) ASSUMED FLOOR TILE AND MASTIC WHICH IS ASSUMED TO BE LOCATED BENEATH CARPET. THIS MATERIAL WILL NEED TO BE VERIFIED AND DAMAGE TO THE EXISTING FLOORING MAY BE REQUIRED.

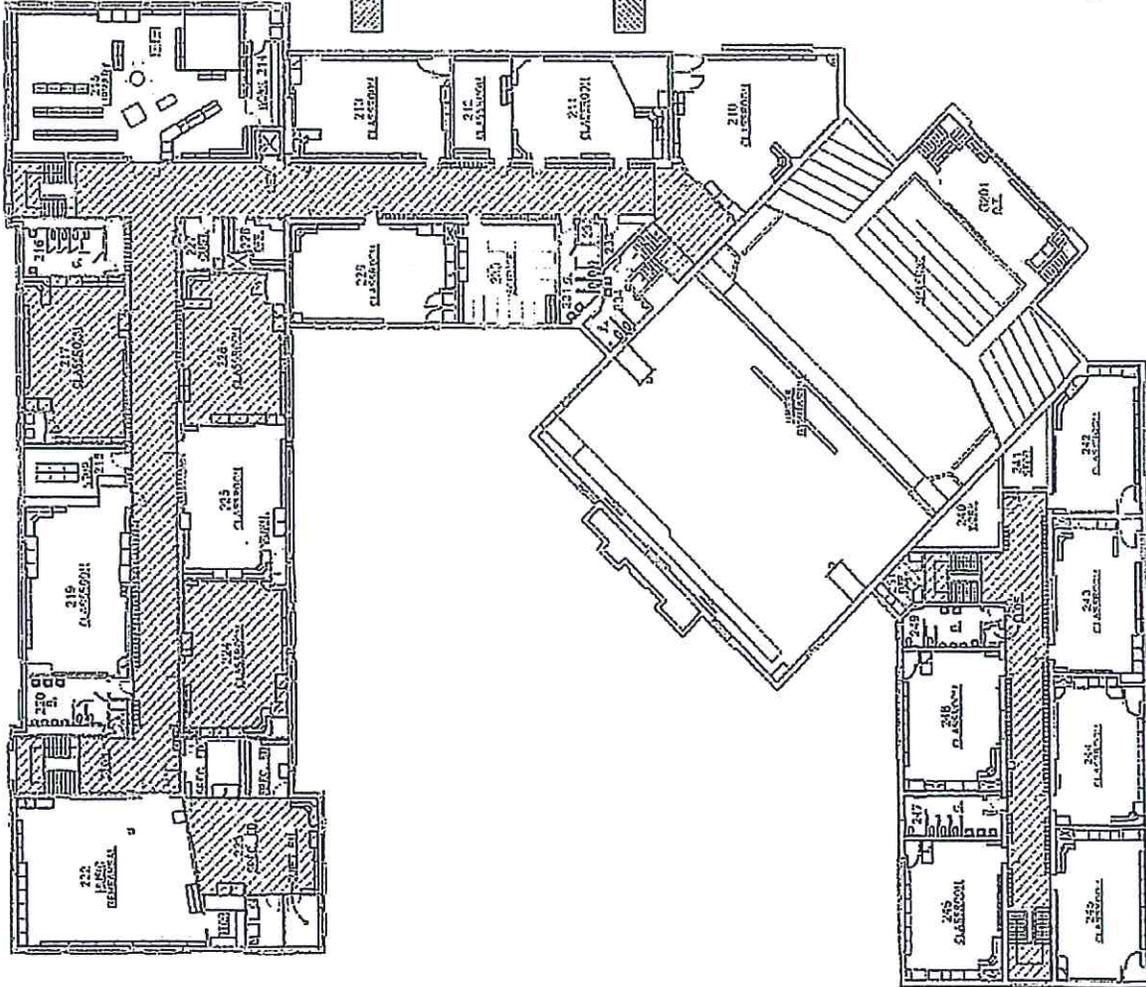
WAIPICTON CENTRAL
 ELEMENTARY SCHOOL
 1929/1949 BUILDINGS
 SECOND FLOOR
 ACM LOCATIONS

---(DRAWING NOTE 17) ASSUMED FLOOR TILE AND MASTIC BENEATH NEW TARKETT FLOORING. NO ABATEMENT RECORDS FOUND WHICH WOULD VERIFY THE MATERIAL WAS ABATED. THESE LOCATIONS WILL NEED TO BE VERIFIED, HOWEVER DAMAGE TO THE NEW FLOORING WOULD BE REQUIRED.

---(DRAWING NOTE 18) ASSUMED FLOOR TILE AND MASTIC WHICH IS ASSUMED TO BE LOCATED BENEATH CARPET. THIS MATERIAL WILL NEED TO BE VERIFIED AND DAMAGE TO THE EXISTING FLOORING MAY BE REQUIRED.
